**Town of Stratham, NH**  
**Trail Inventory and Assessment**

**Stratham Hill Park, Gordon Barker Town Forest, and adjacent properties**

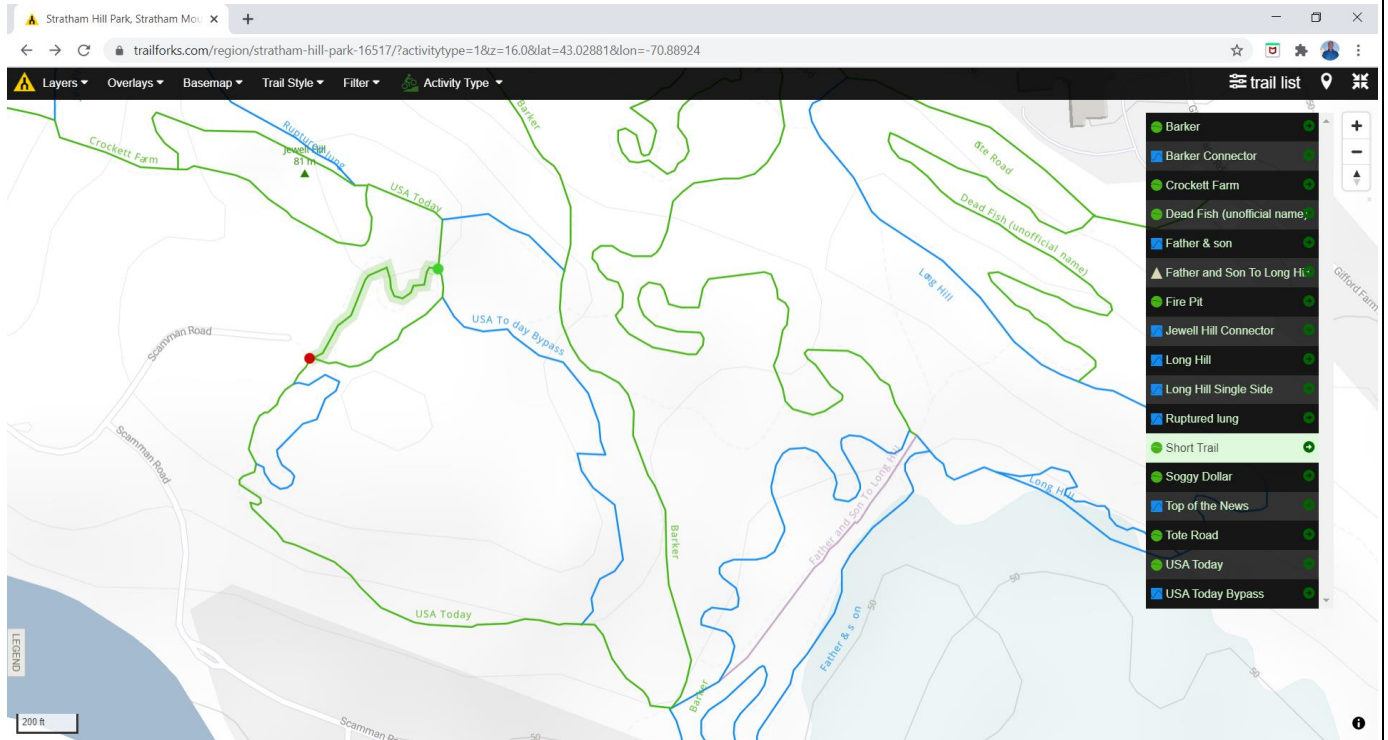
## **20. Short Tail (704')**

- A short and meandering optional route to the west of USA Today near the end of Scamman Road.
- In good shape with one boardwalk that is also in good condition.
- Close to adjacent neighborhood and also the upper section of Crockett Trail.
- Used by hikers and bikers.
