BARTLETT-CUSHMAN HOUSE
CHARACTER DEFINING FEATURES REPORT

BARTLETT-CUSHMAN HOUSE
82 PORTSMOUTH AVENUE
STRATHAM, NH

Character Defining Features

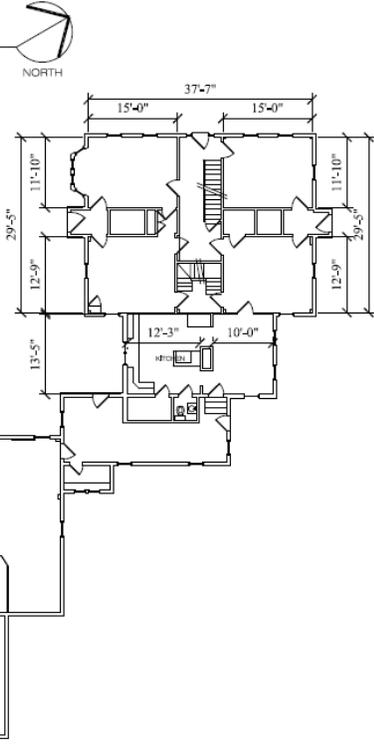
First Floor Plan

Portsmouth Avenue

← Bunker Hill Avenue →

The interior spaces of the main house are consistent with the Federal style noted on the house exterior. Primary character defining interior spaces are the stair hall on the first and second floors, the main house side entrance vestibules, the main house front rooms on both floors, and the first floor NE room. The rear stairway, the first floor SE room and the two rear second floor rooms are secondary character defining spaces.

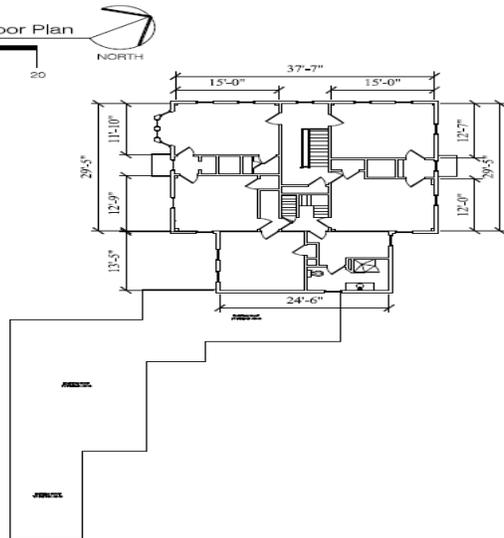
Second Floor Plan

← Portsmouth Avenue →

← Bunker Hill Avenue →
